Debris/Ice/TPS Assessment and Integrated Photographic Analysis of Shuttle Mission STS-69

Gregory N. Katnik, Barry C. Bowen, J. Bradley Davis

DEBRIS/ICE/TPS ASSESSMENT
AND
INTEGRATED PHOTOGRAPHIC ANALYSIS
OF
SHUTTLE MISSION STS-69

7 September 1995

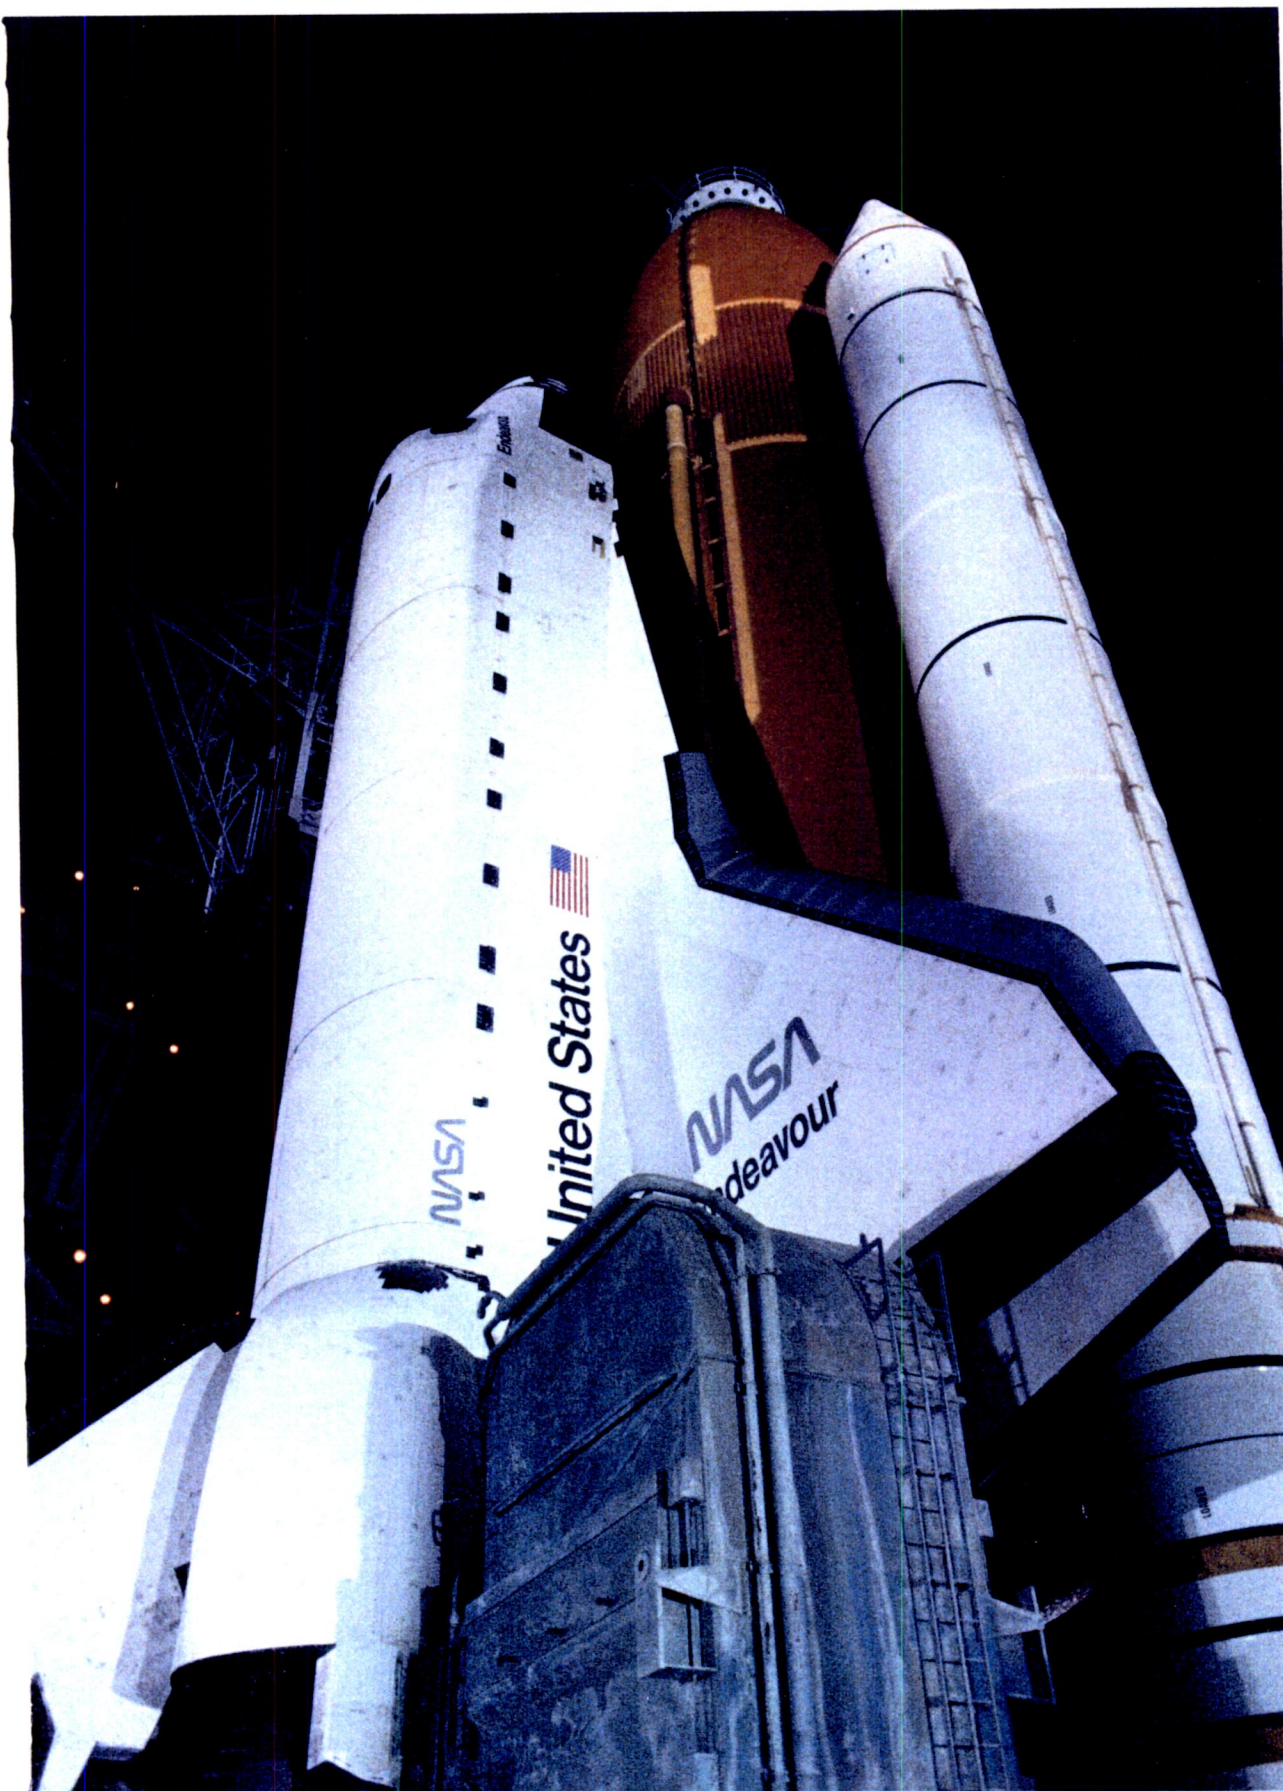
Photo 2 : Vehicle After Cryoload

OV-105 (9th flight), ET-72 (LWT 65), BIO74 SRB's

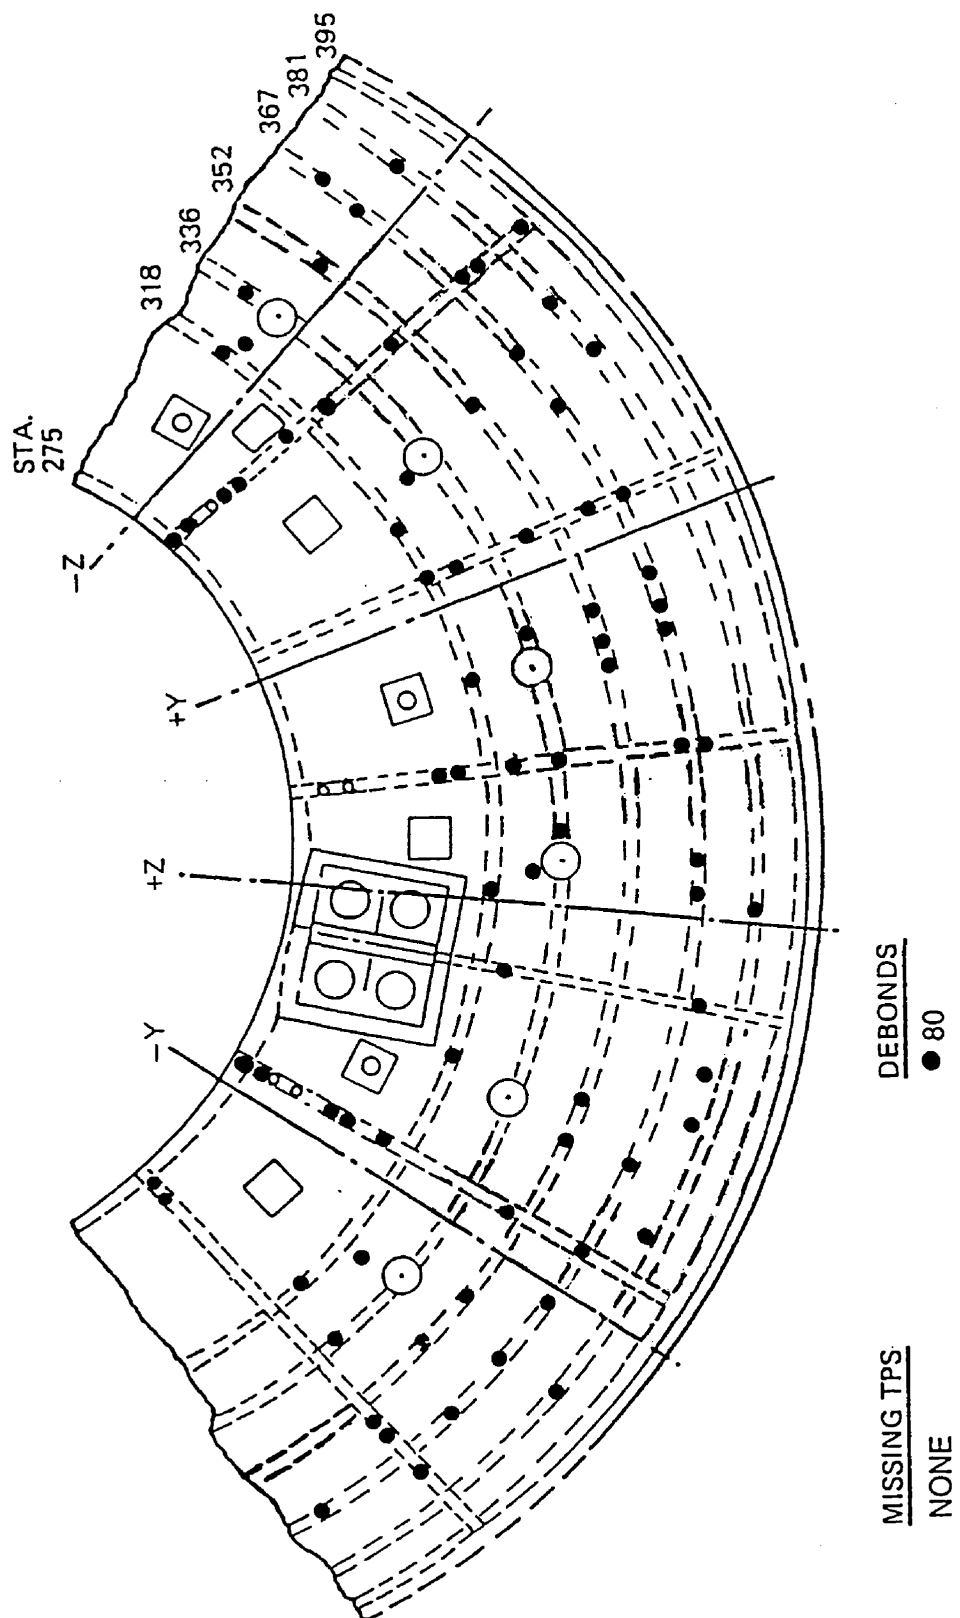
Figure 1 : RH SRB Frustum

The RH frustum was missing no TPS. The number of debonds (80) over fasteners was greater than average (Figure 1). Hypalon paint was blistered/missing along the XB-395 ring frame where BTA closeouts had been applied. Some of the underlying BTA was sooted. The BSM aero heat shield covers had locked in the fully opened position.

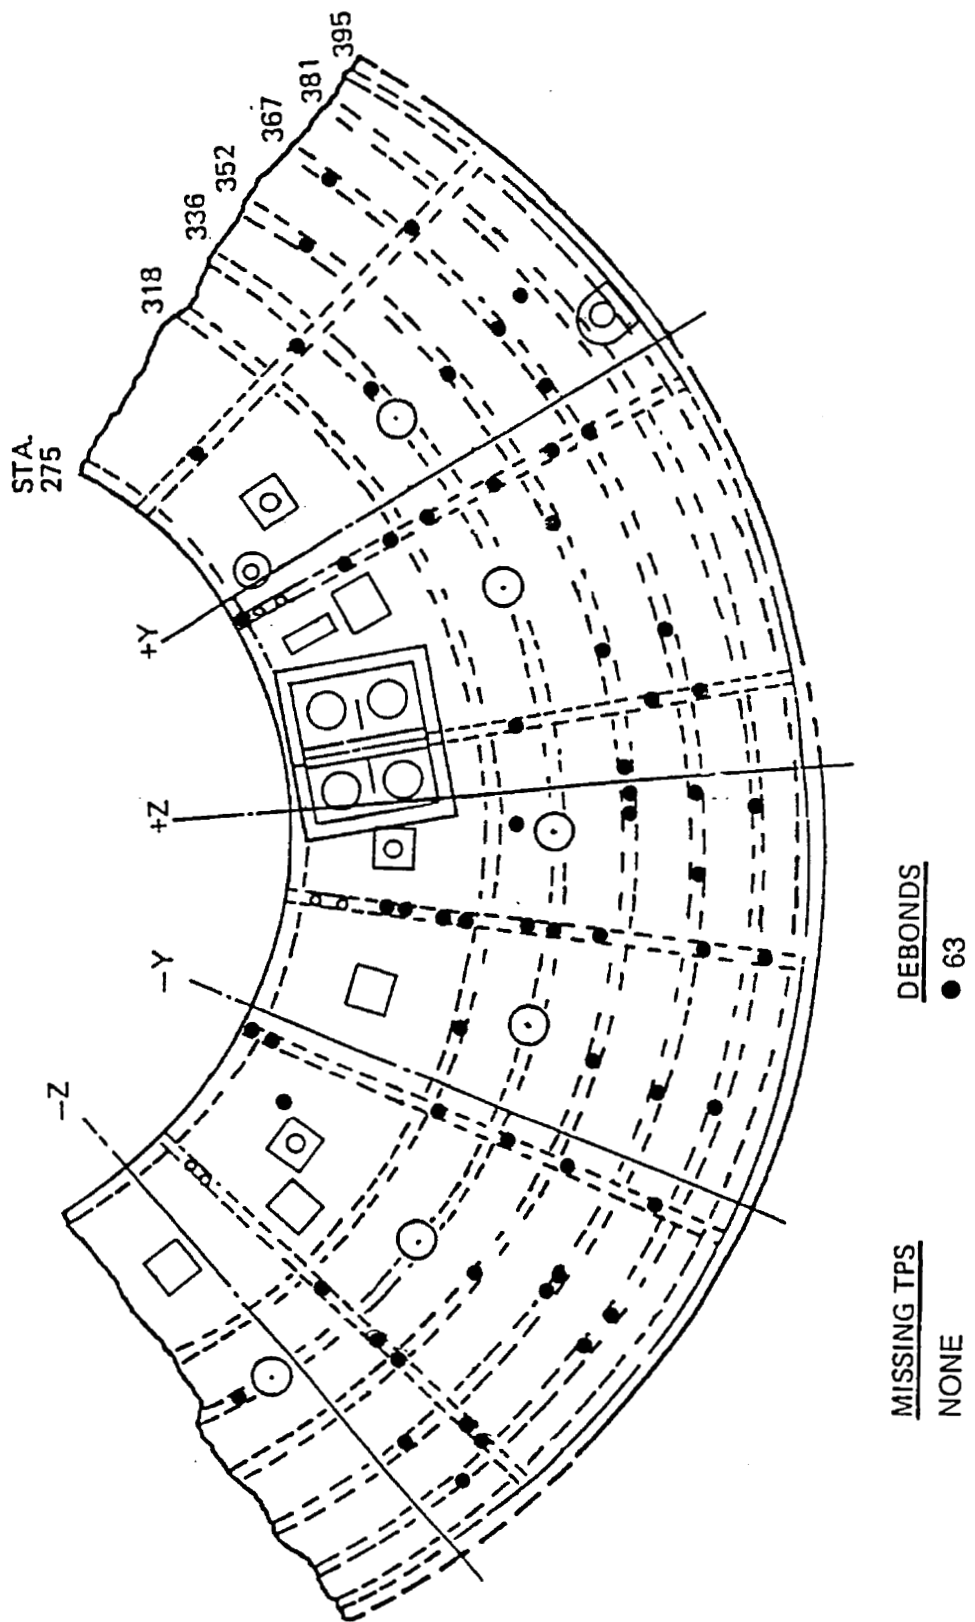
Figure 2 : LH SRB Frustum

The LH frustum was missing no TPS. The number of MSA-2 debonds (63) over fasteners was greater than average (Figure 2). Hypalon paint was blistered/missing along the XB-395 ring frame where BTA closeouts had been applied. Some of the underlying BTA was sooted. The BSM aero heat shield covers had locked in the fully opened position.

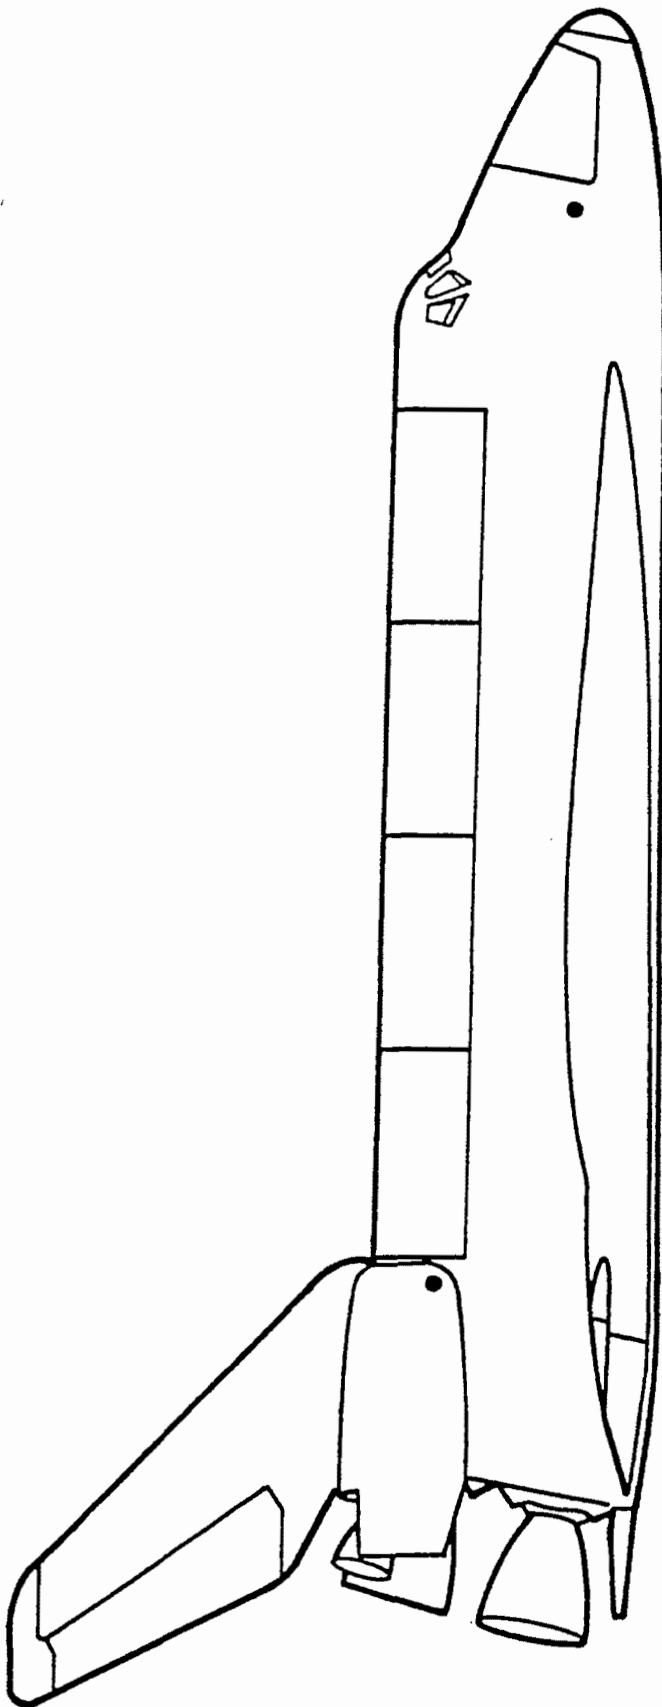
Figure 4 : Orbiter Right Side Debris Map

TOTAL HITS = 2
HITS \geq 1 INCH = 0

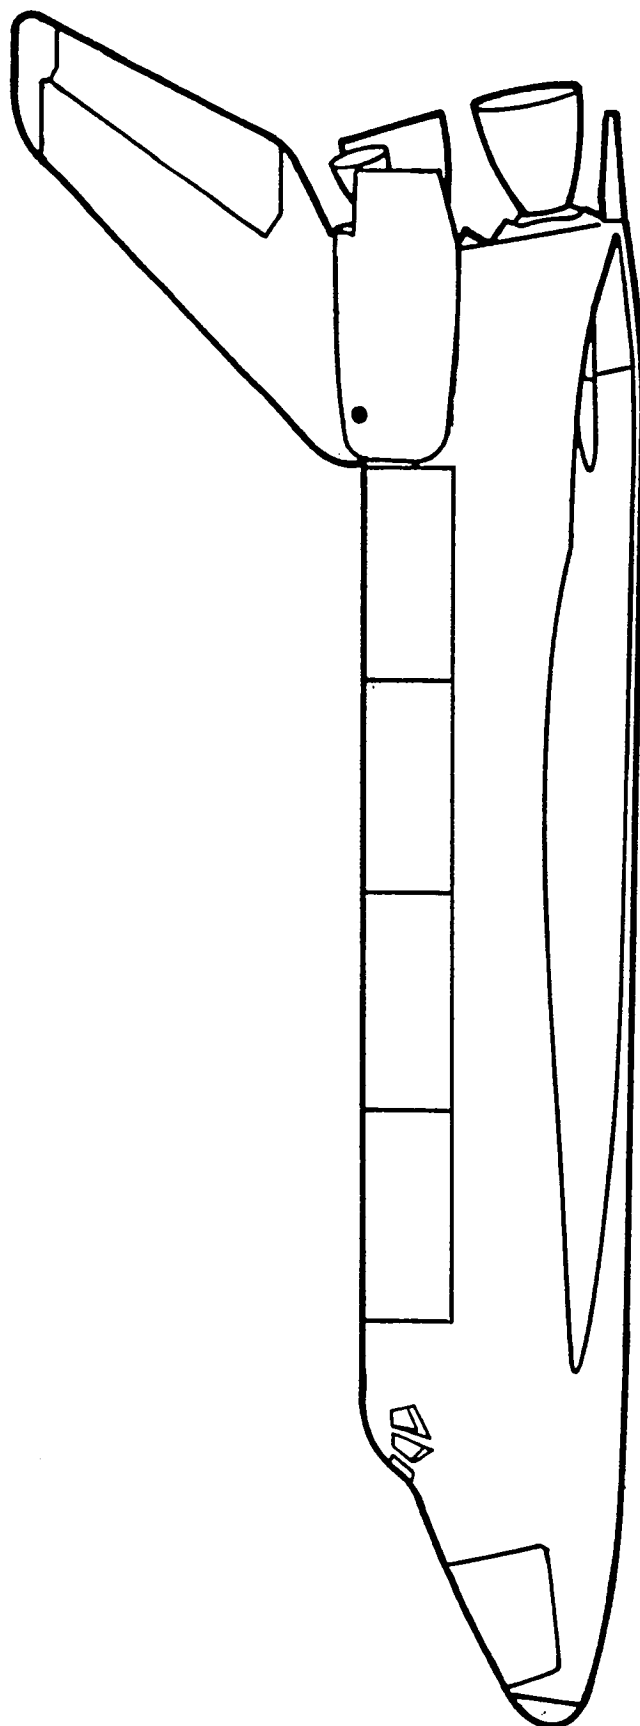
Figure 5 : Orbiter Left Side Debris Map

TOTAL HITS = 1
HITS \geq 1 INCH = 0

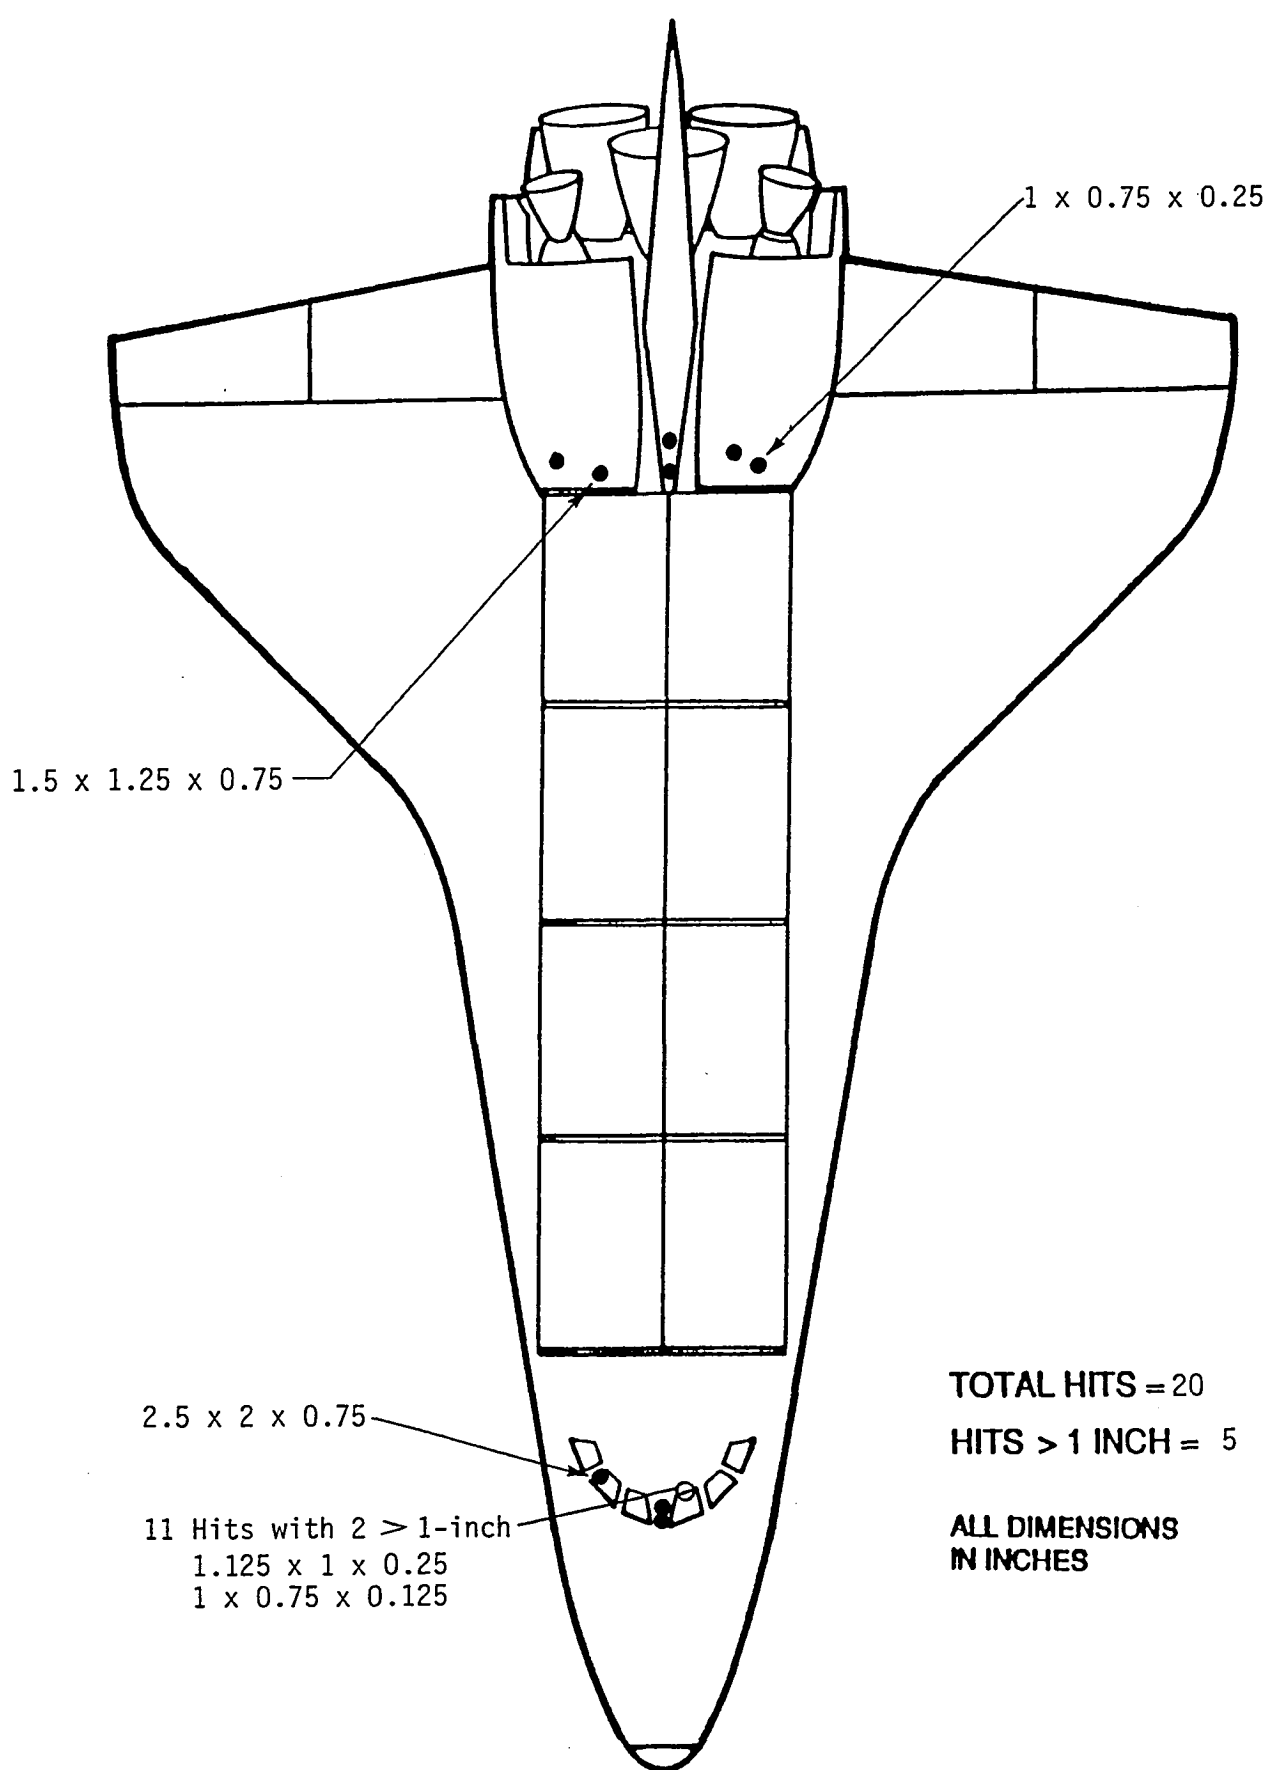
Figure 7 : Orbiter Post Flight Debris Damage Summary

In summary, both the total number of Orbiter TPS debris hits and the number of hits 1-inch or larger was greater than average when compared to previous missions (Figure 7).

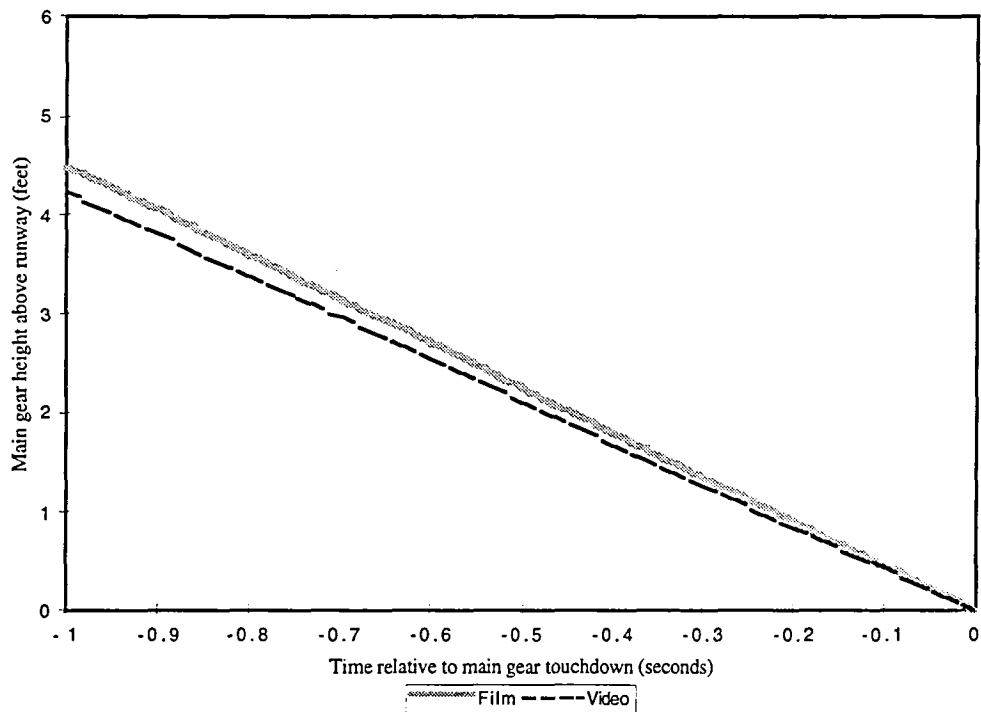
Figure 2.5.1 (A) Main Gear Sink Rate from Film (EL9) and Video (Runway South) (shown as trend of data points)

The measured main gear and nose gear sink rate values were found to be below the maximum allowable values of 9.6 ft/sec for a 211,000 lb. vehicle and 6.0 ft/sec for a 240,000 lb. vehicle (the landing weight of the STS-69 Orbiter was reported to be 219,377 lbs.). The sink rate measurements for STS-69 are given in Table 2.5.1. In Figures 2.5.1 (A) and 2.5.1 (B) the trend of the measured data points for both film camera image data and video image data are illustrated.

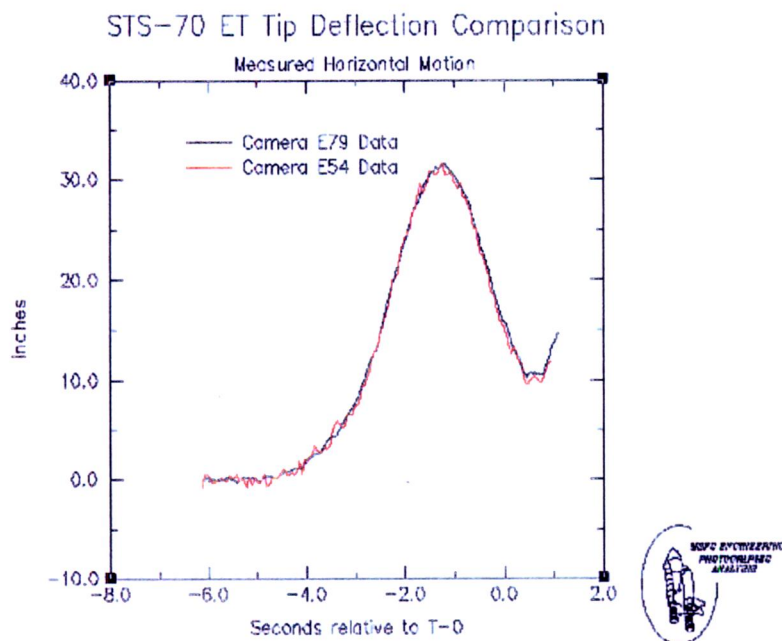
Figure 2 ET tip deflection comparison

This analysis is planned to be eliminated unless requested. A reduction in film camera coverage is planned which includes camera item E79. Item E79 specific purpose was for this analysis. However, this analysis can be performed using other camera items but at a reduced spatial resolution. A comparison, shown in Figure 2, was made to ensure this capability.
